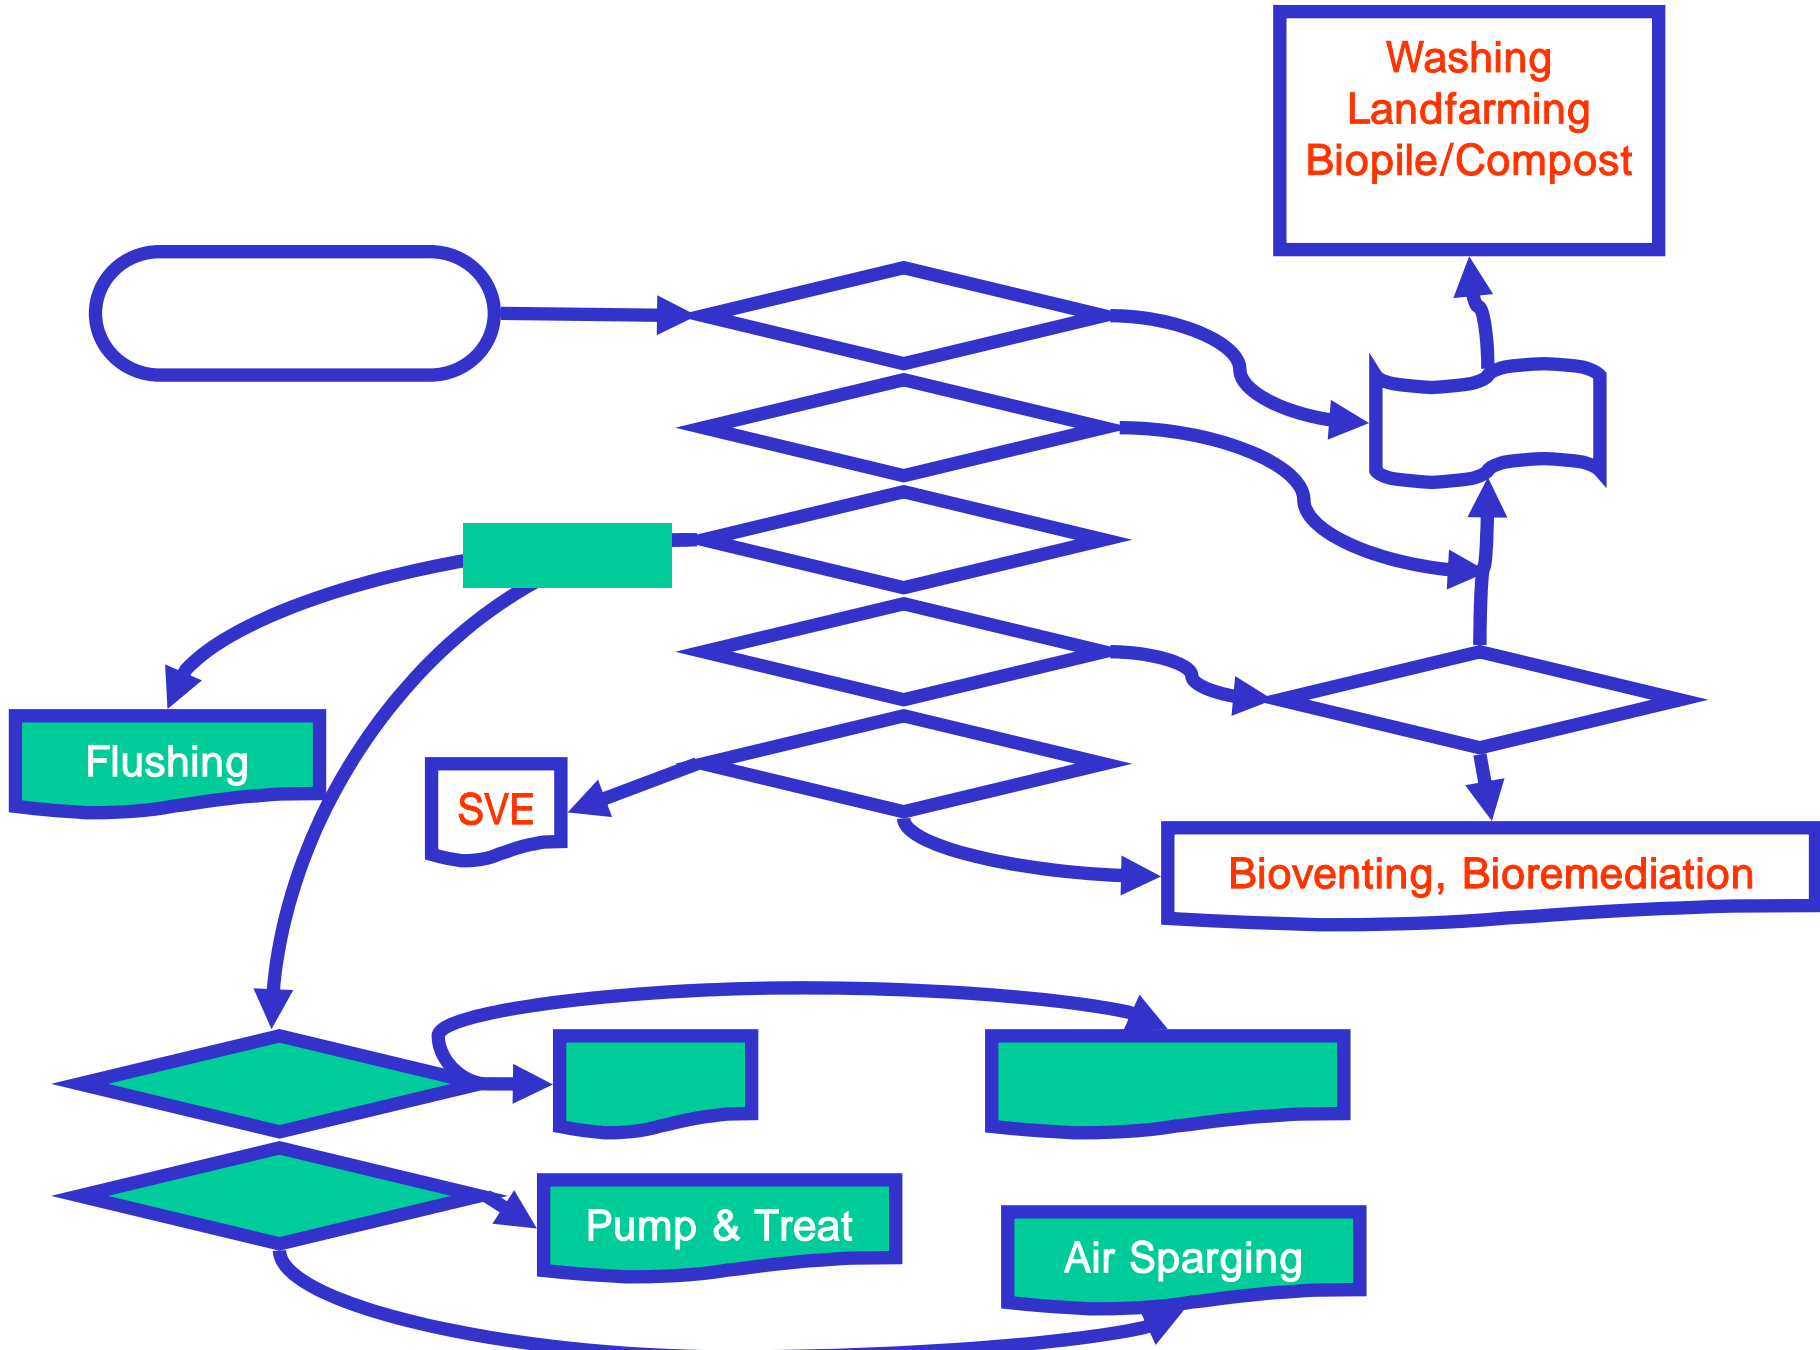
Washing
Landfarming
Biopile/Compost

Flushing

SVE

Bioventing, Bioremediation

Pump & Treat

Air Sparging

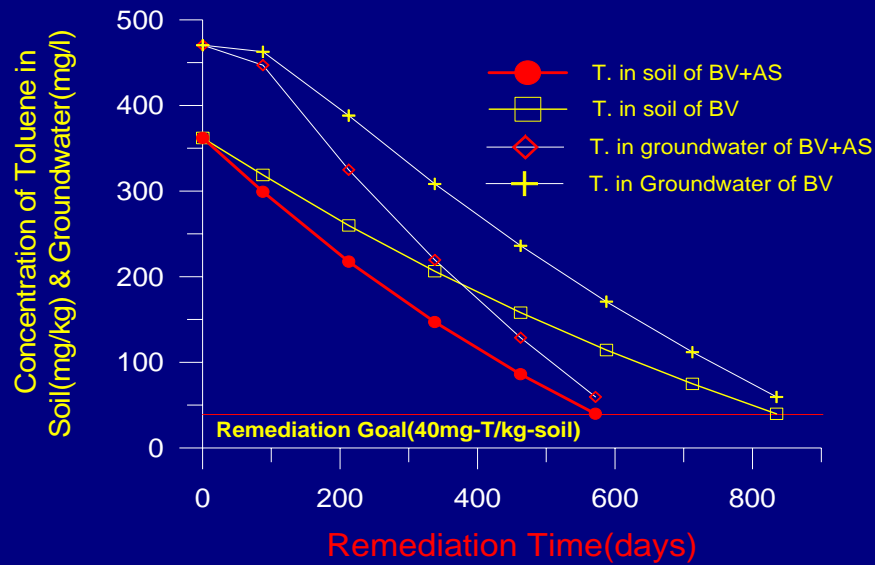
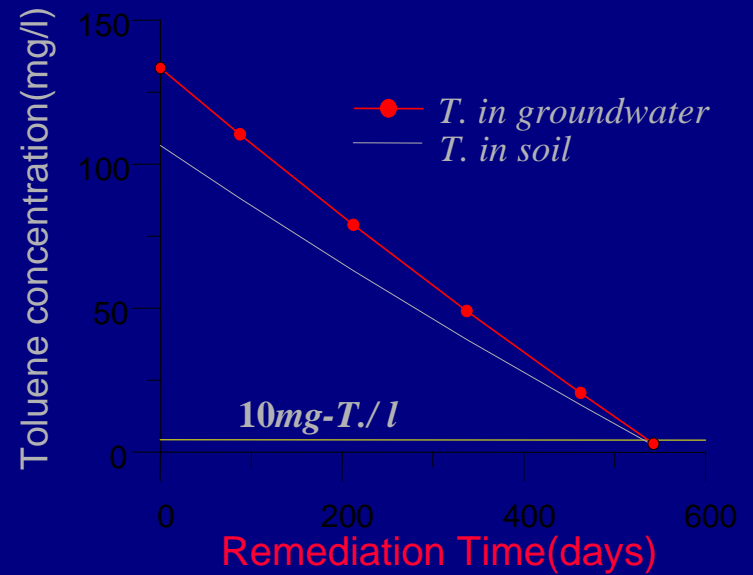
Cleanup time : 580 days
